Dr. Brian Hornberger  
*presents*

# Case of the Month

April 2011

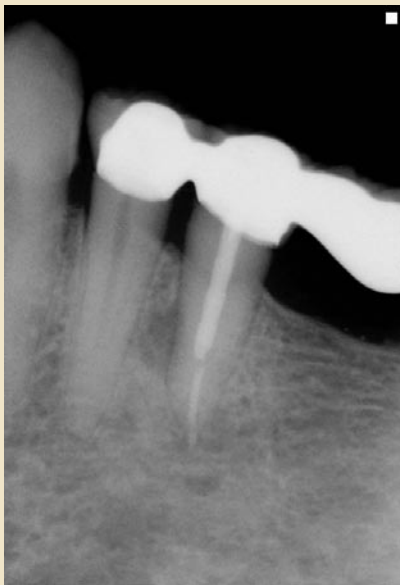
*Before*

This patient was referred for a failing endodontically treated tooth #20. Note the presence of a lateral radiolucency present at the depth of the post placement. This is a clue indicating either an unsealed lateral canal or root fracture.
